INVESTOR CLASSICS

THIS VEHICLE

This vehicle is a 2001 BMW e39 M5 with the post-2001 facelift

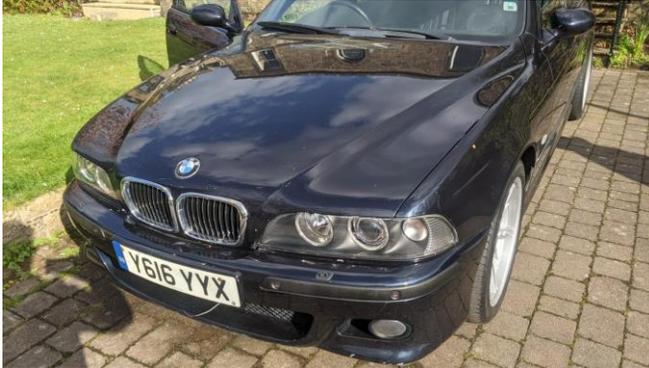
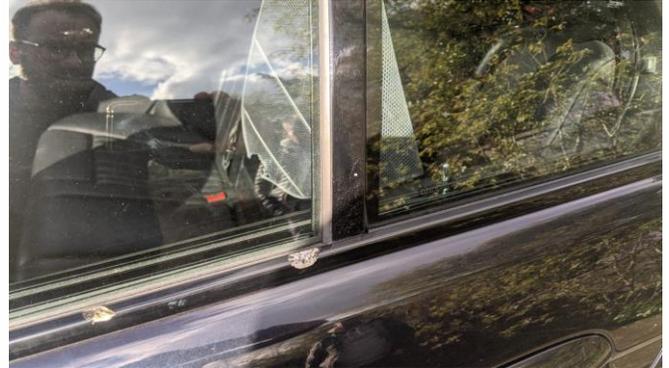
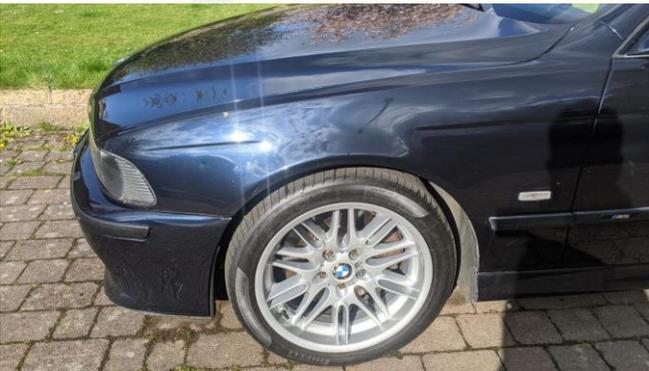
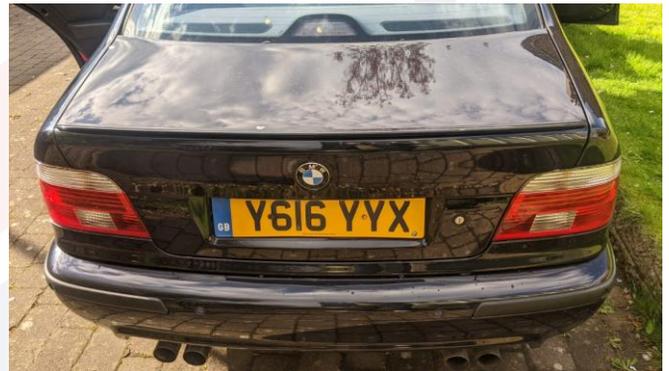
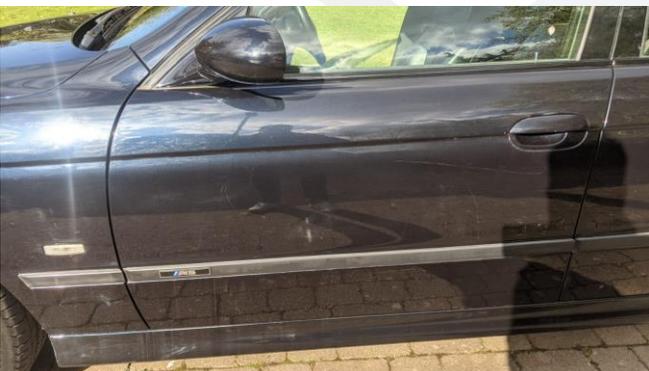
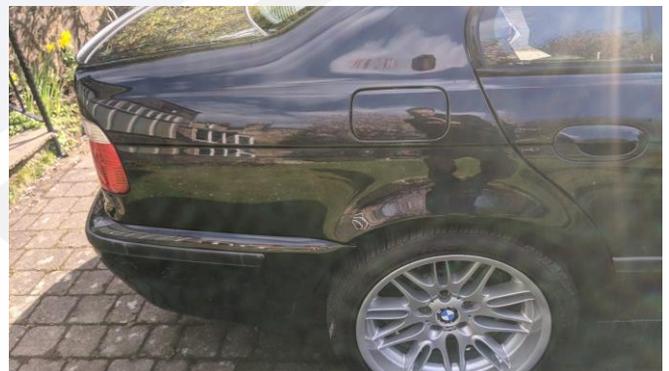
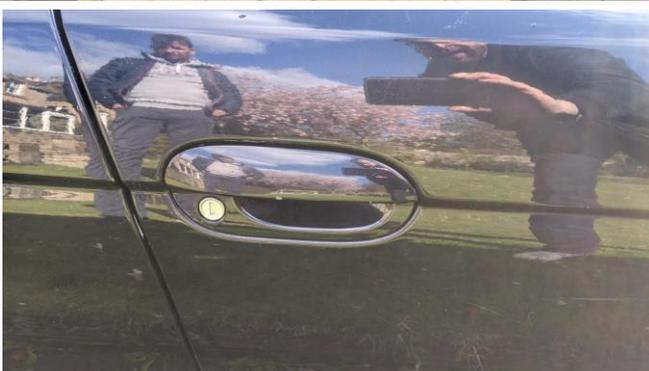
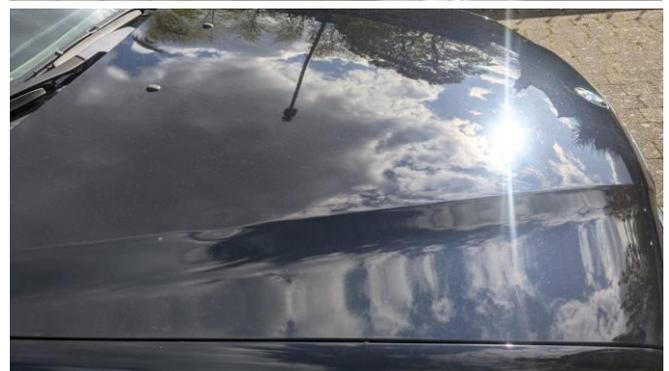
The vehicle is showing signs of its age but can be restored to a new condition. All panels need restoration work, with dings, scratches and tired paint. There is a crack to the front bumper, broken undertray, and chip to the rear spoiler. A full respray of the car is needed. Badges will need to be replaced on the bonnet and the wheels as they are getting old. There is bubbling to the B pillar trim, which is common. Wheels have been restored. There are no signs of rust except for tailgate and inside petrol cap area. We believe the tail pipe can be polished to new.

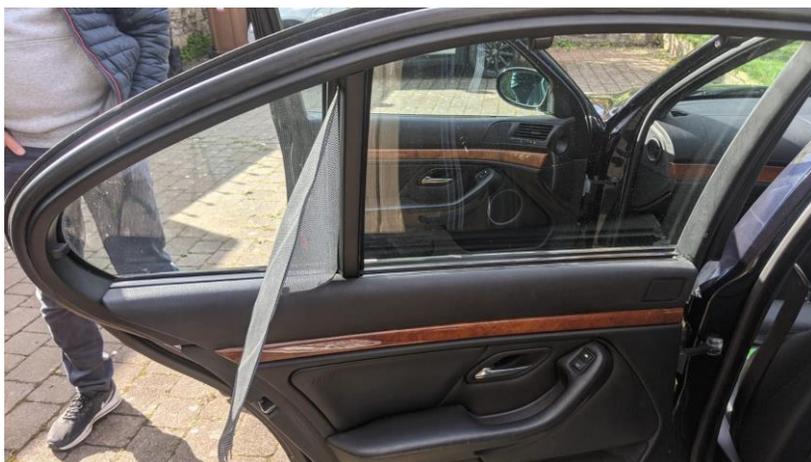
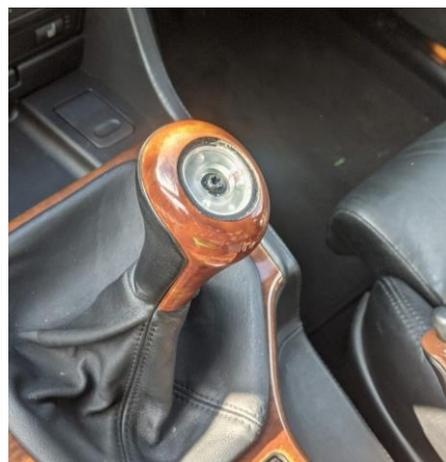
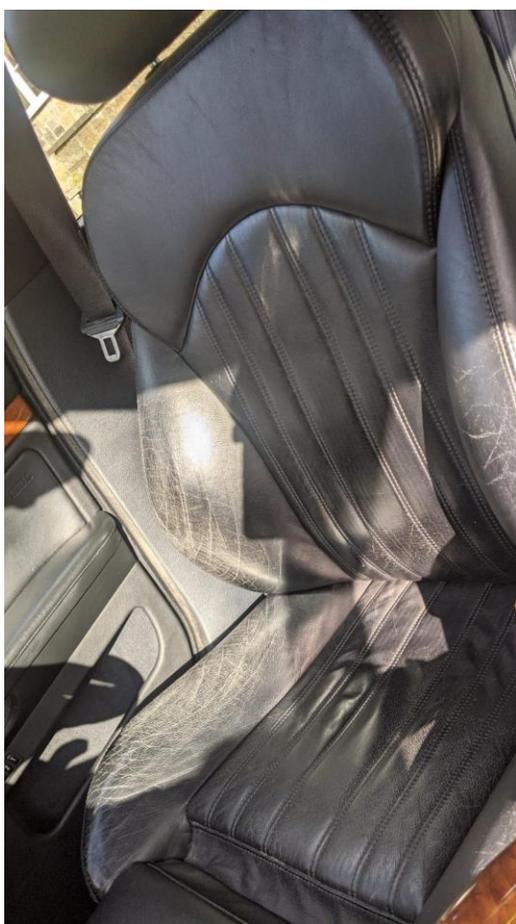
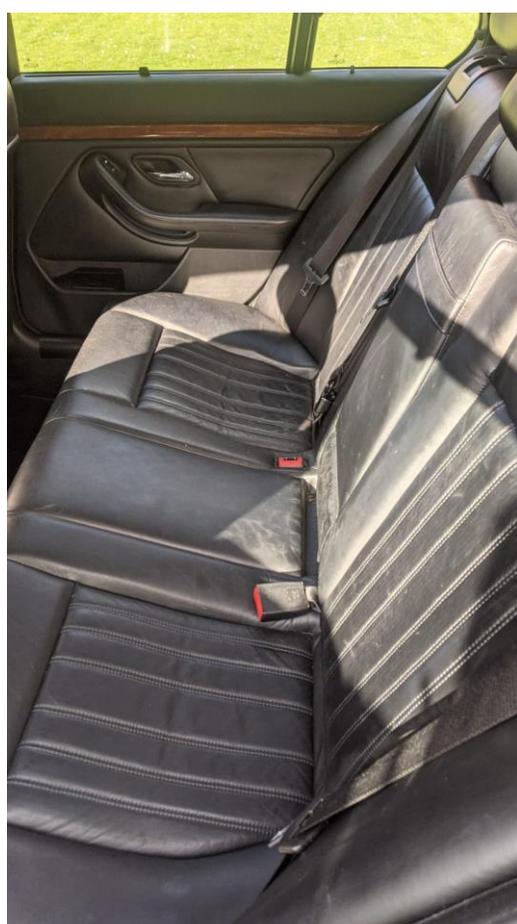
The interior needs to be restored with Colourlock leather restoration products as it needs to be restored with moisture and colour. However, the seats are all structurally in great condition with no rips, tears, scuffs or bolster wear.

The cap for the gearknob is missing, and the rear sun blinds have suffered 'child damage' 15 years ago so will need replacing.

The rear view mirror needs to be replaced and the pixels on the dash could be repaired. Overall, the interior is in good condition.

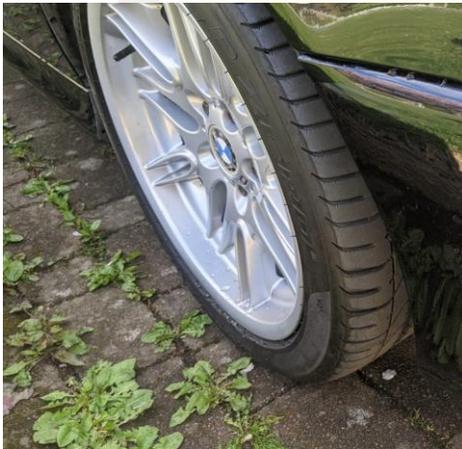
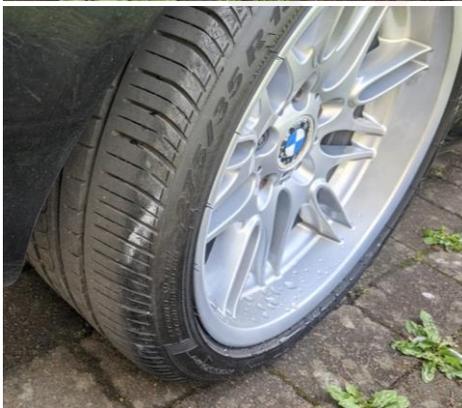
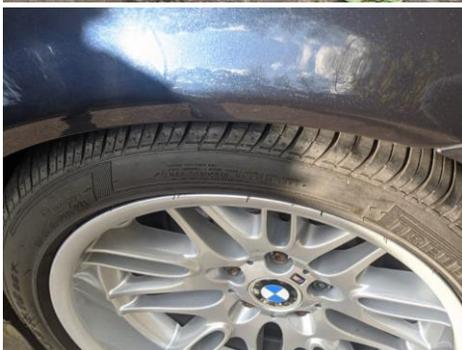
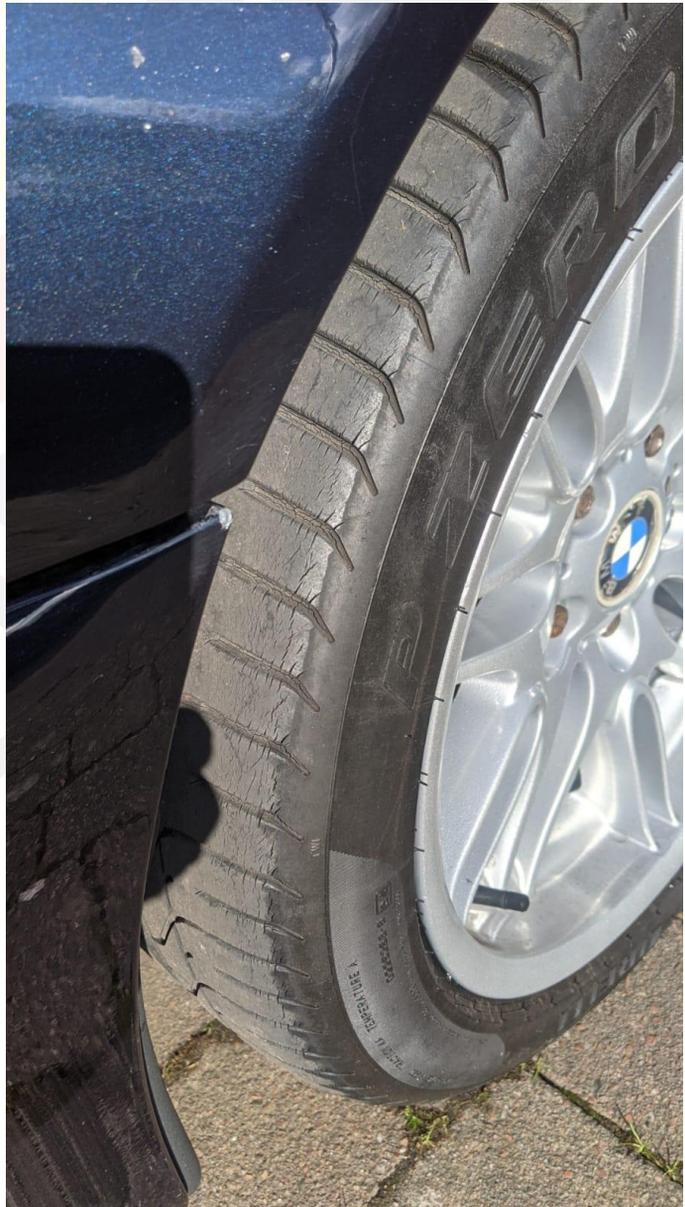
Wheels and tyres

The wheels have been restored this year, but centre caps will need replaced. The tyres are all good brands, and have plenty of tread, but due to the very low mileage and use, they have been fitted some time ago and are all cracked. The vehicle will therefor need 4 new tyres.

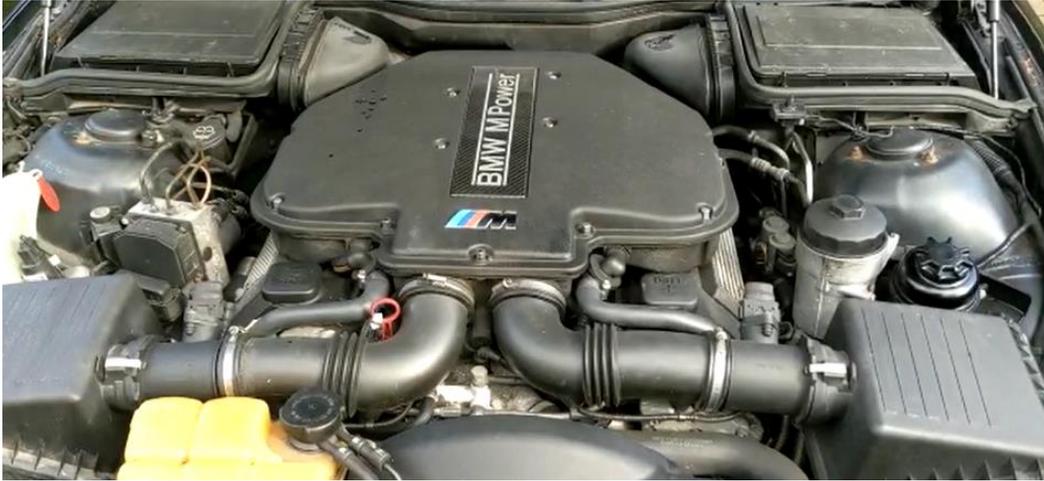
Engine Bay

The engine bay looks clean and tidy. The only issue observed was water ingress from either condensation, leaking washer seals or leaking washer jets. This has caused mould to form on the heat proofing, which can be cleaned when the root cause is fixed.

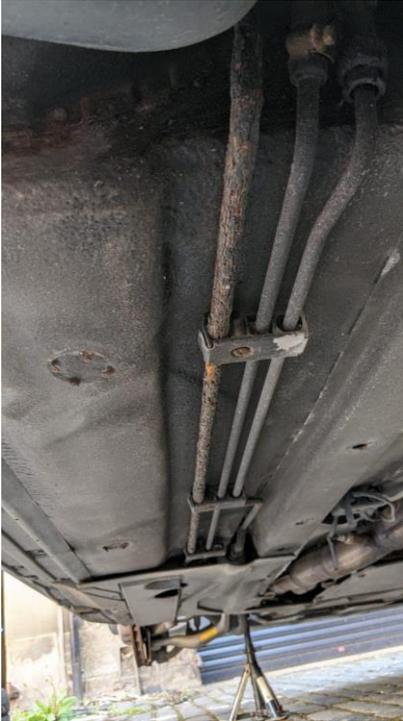
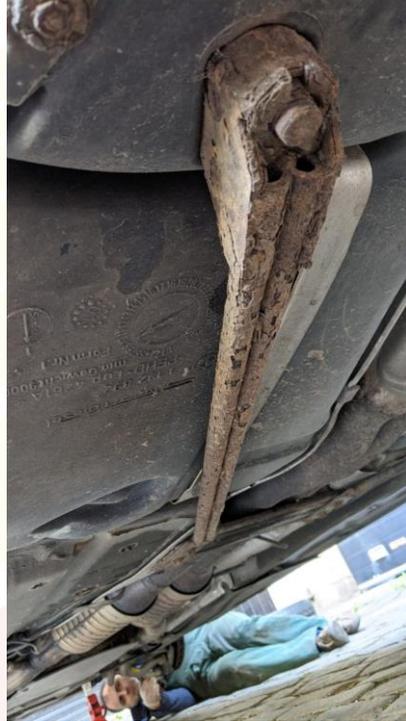
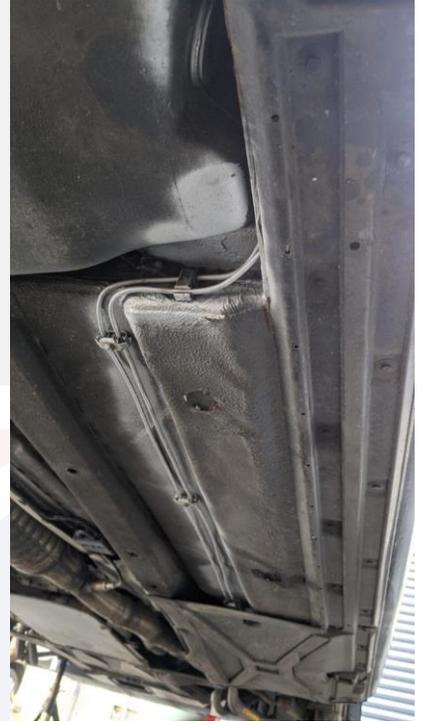
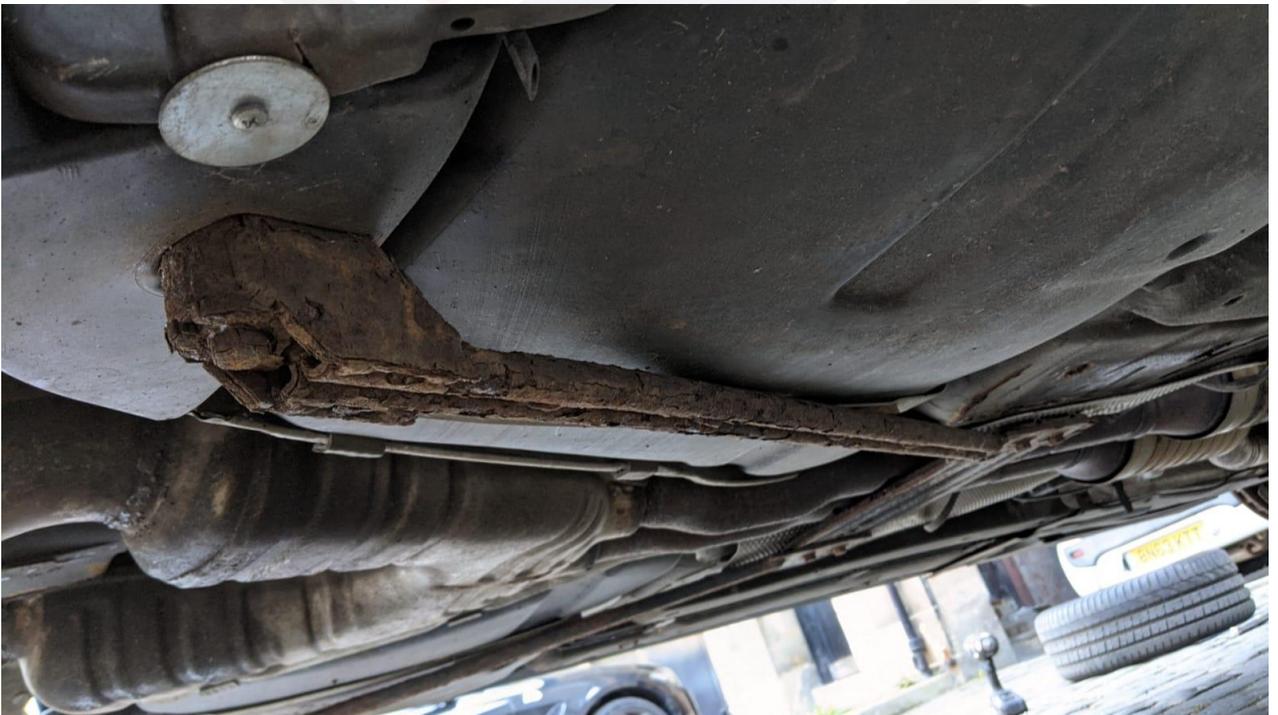
Underbody

The fuel breather pipe in photo 1 (closest to sill) is corroded. The underbody rear chassis brace is also excessively corroded. Everything else looks in good condition.

Two components need to be replaced.

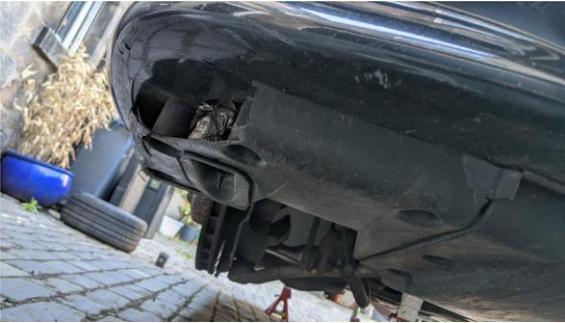
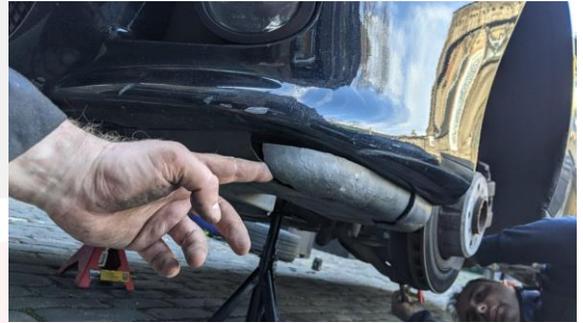
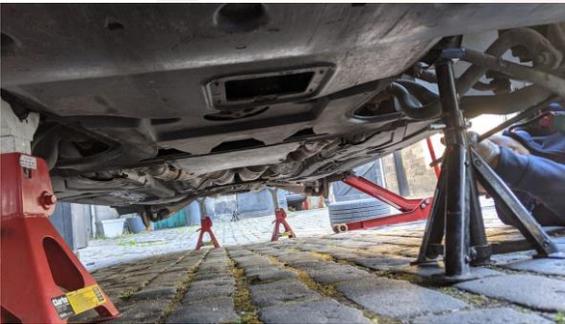
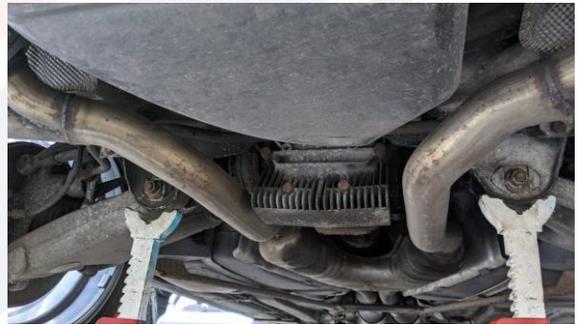
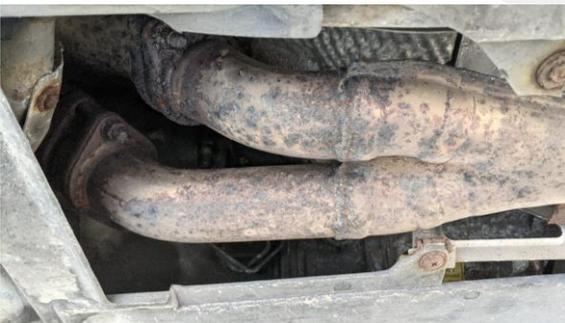
Underbody

The front end of the car has 3 plastic undertrays . Two of these are damaged and could be replaced. This is common in Edinburgh, where there are lots of cobbled streets with sharp hills with speed humps.

The back exhaust system looks in good condition. The mild steel exhaust manifold is showing some early stages of corrosion. It does not need to be replaced in the near future but may need to be replaced in coming years.

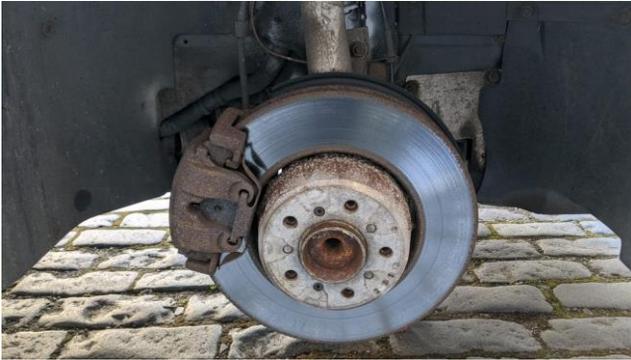
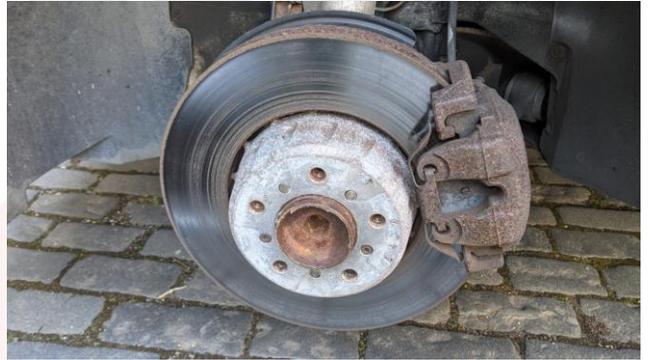
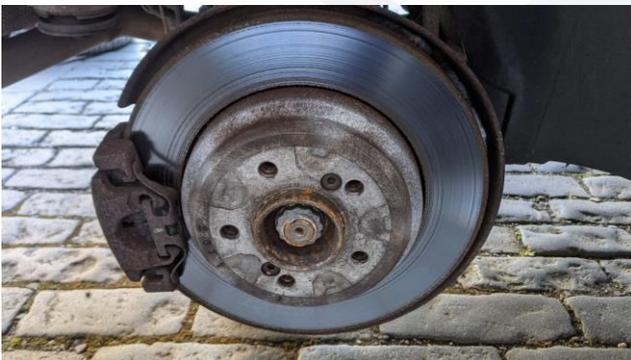
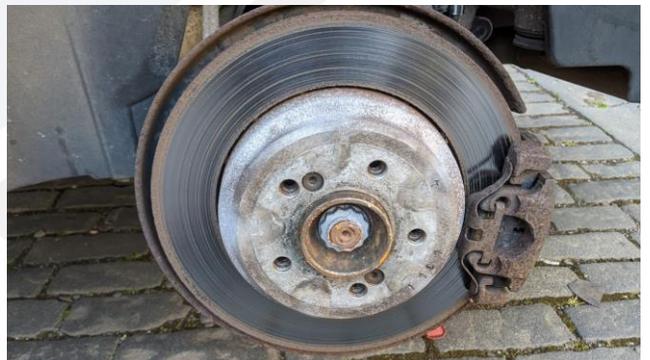
Brakes

All four disc brakes are scored and we advise changing them.

BMW floating vented discs are very expensive, so we have quoted for excellent aftermarket drilled performance upgrades that are a fraction of the price but offer better stopping power.

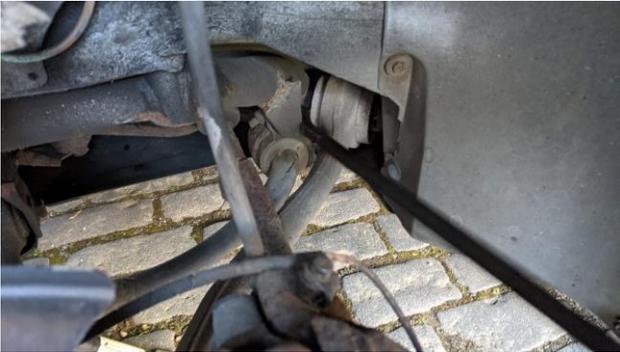
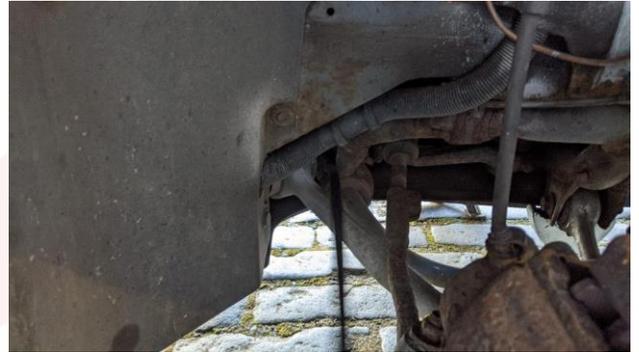
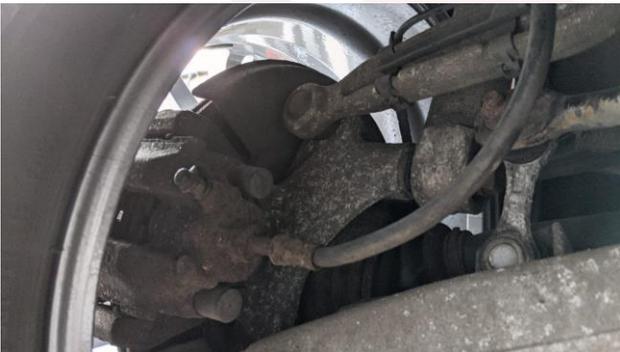
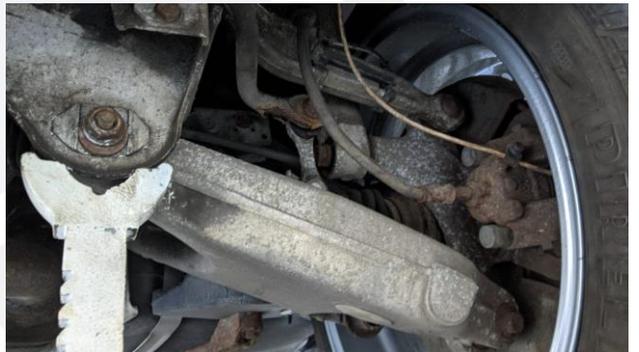
Suspension

There is excessive play in the NS rear wheel, traced to a worn upper suspension bushing. This may or may not be caused by the NS rear shock absorber having reduced effectiveness due to loss of oil.

There was also some slight play in the front lower suspension bushings.

All suspension components have surface corrosion. Whilst this looks unpleasant it is common on cars even half this age and should not put you off. If you are opting to change all of the bushings, we would recommend that whilst components are stripped from the vehicle, you have these shot blasted and powder coated where applicable. This would protect them for years to come.

We recommend all three are changed, with the optional work of changing all bushings and shocks. This would completely transform the car.

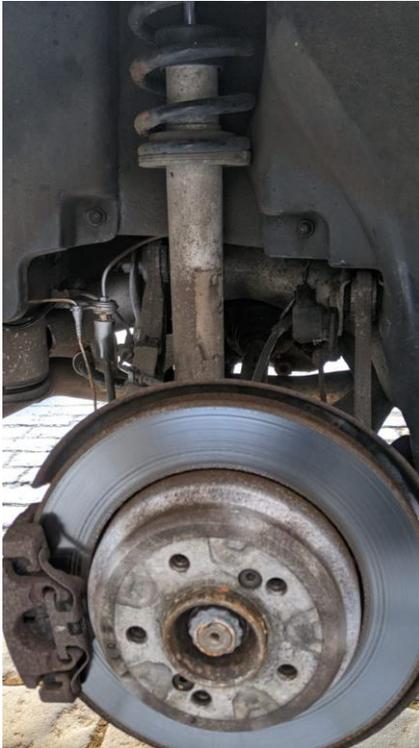
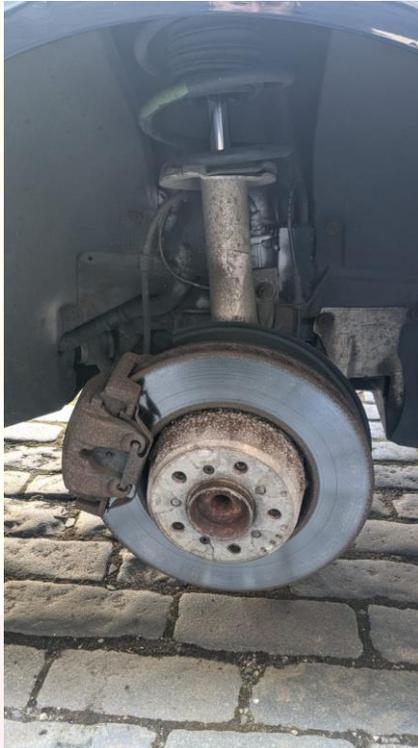
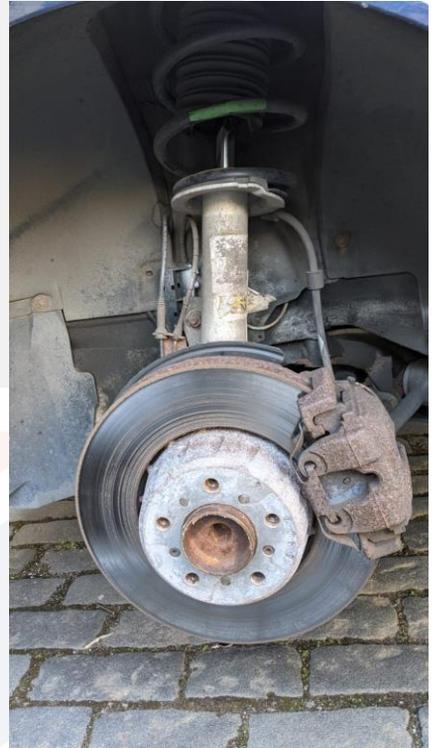
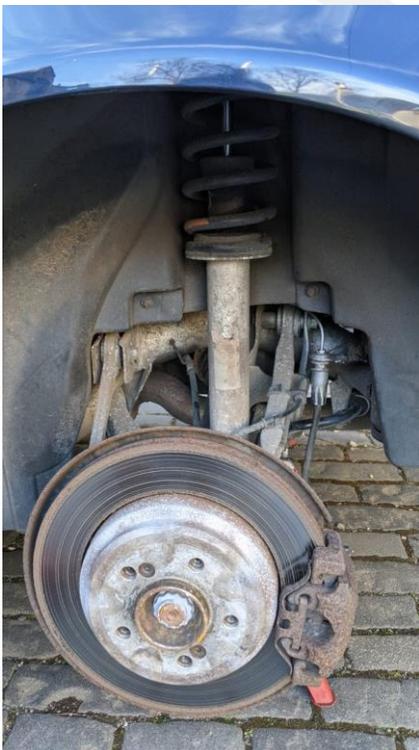
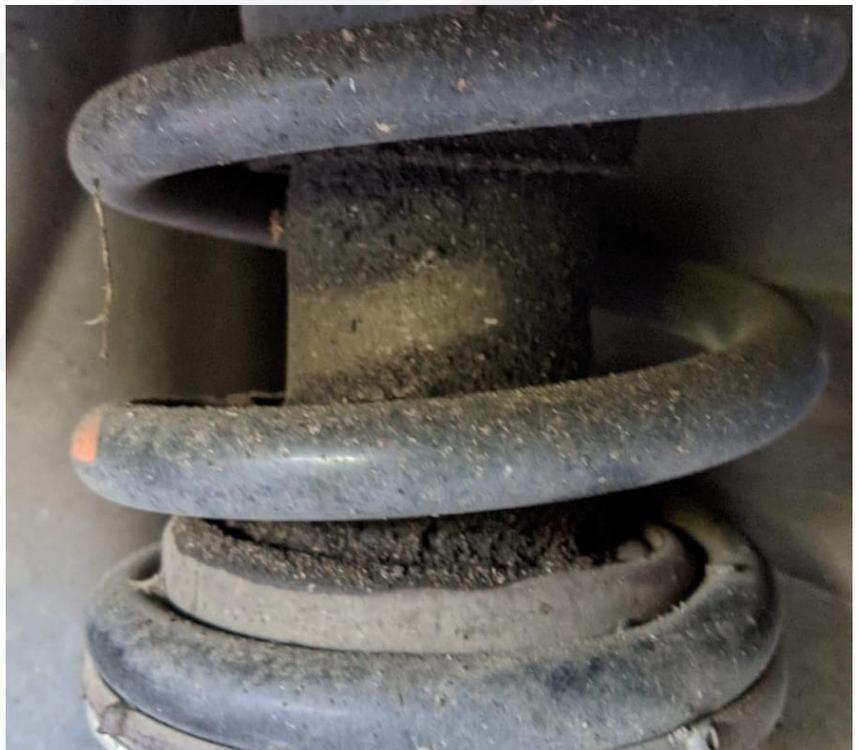
Suspension

The NS rear shock absorber has a misting of oil present that suggests a loss of pressure and effectiveness, however this will be slight. It may have caused the premature wear of the suspension bushing that has play in it. Replacement is not essential. If you opt for replacement, this will again transform the car and make it laser sharp. We recommend uprated Bilstein dampers which are the same price as BMW. We always fit Bilstein.
