RESTORATION DOCUMENTATION

FORD ESCORT RS COSWORTH

Chassis number: WF0BXXGKABSM92727

Ford Escort RS Cosworth – 9 Month Restoration

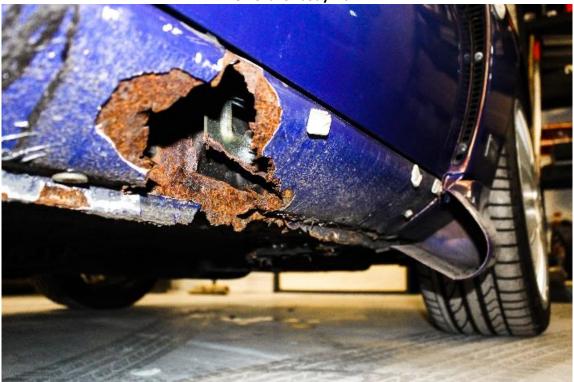
Sills rusted through underneath body kit, also eating into the edge of the floor

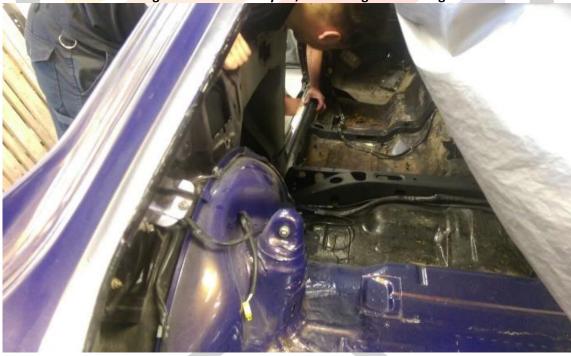
Assessing the extent of the damage

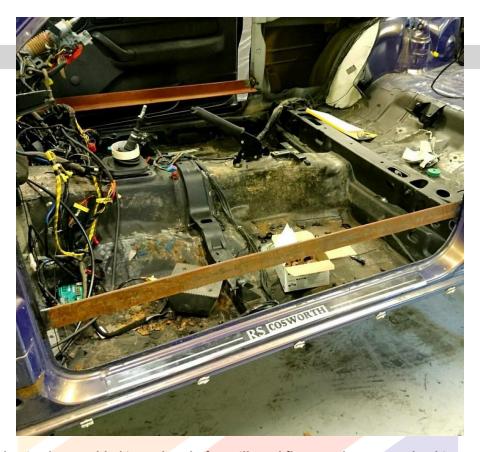
Strengthening bars welded into place before sills and floor can be removed – this retains the rigidity of the shell when the structural members are replaced

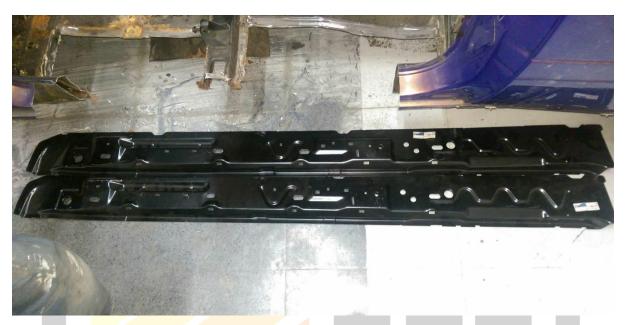
New sills had to be sourced from America as there were none available in Europe

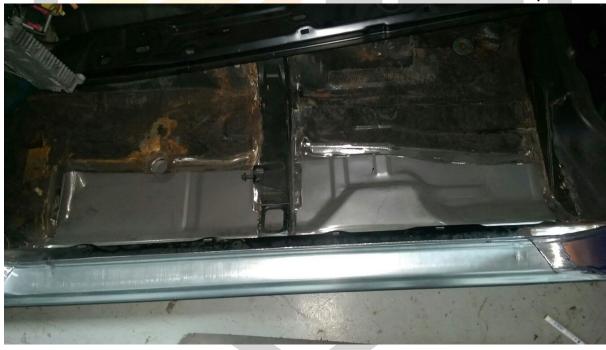
Old floor cut out and new one offered up for sizing and trimming

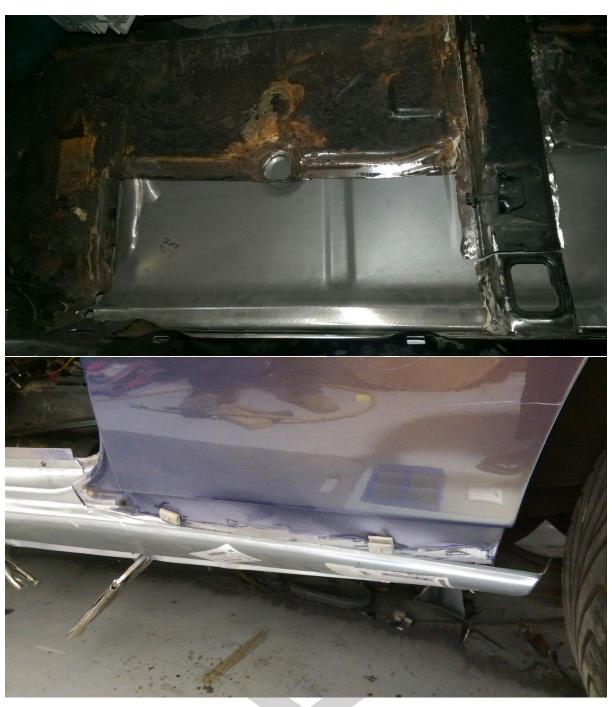
New outer sill measured for cutting and fitting

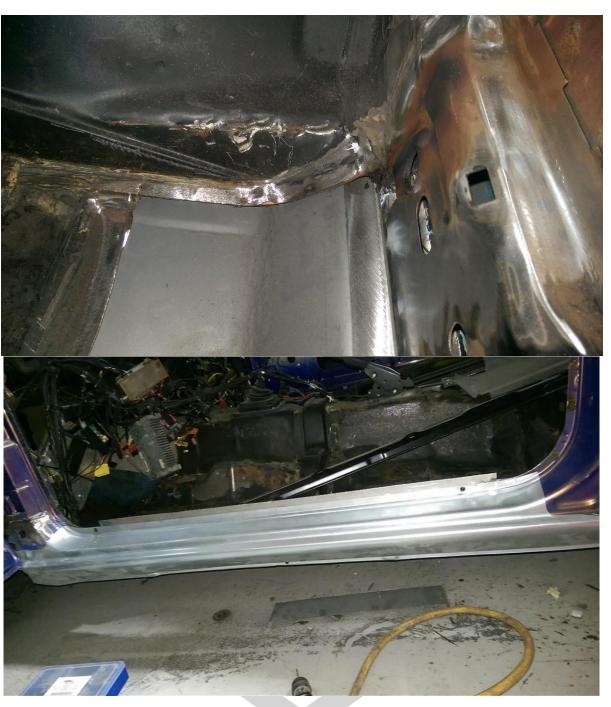
New floor, inner & outer seals in place and car ready for paint prep

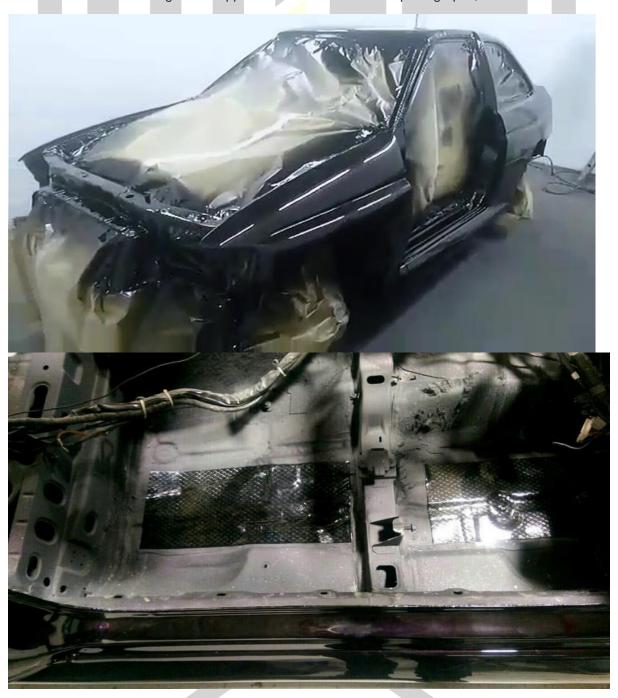
After bodywork and structural work, the car was stripped down and prepped with zinc galvanising primer, prior to a build up of Dark Aubergine paint. This was then flatted and lacquered.

The floor also had a coating of zinc applied as can be seen on the photographs, then undersealed.

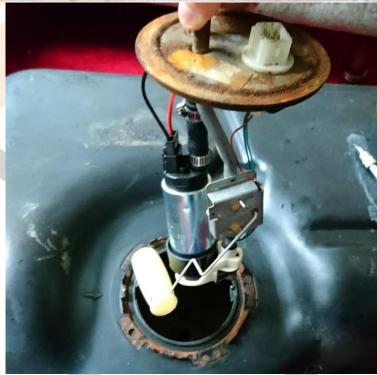
Fuel pump replacement

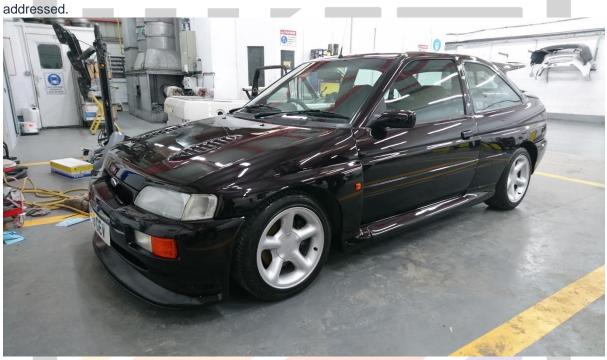
Once the car was reassembled, the car underwent quality control. Any slight imperfection was marked with a small square of masking tape, as can just be made out in the photographs. These were then
