INVESTOR CLASSICS

THIS VEHICLE

This vehicle is a 2001 BMW e39 M5 with the post-2001 facelift

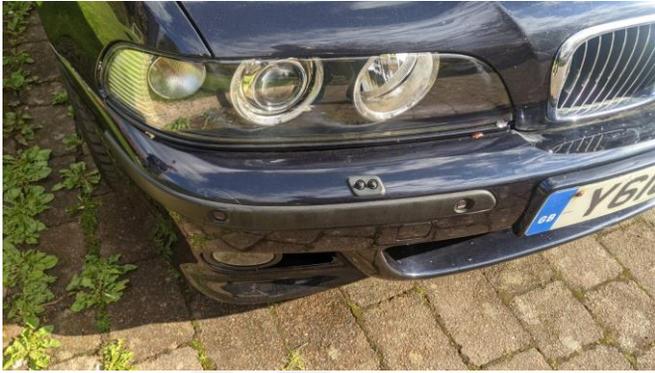
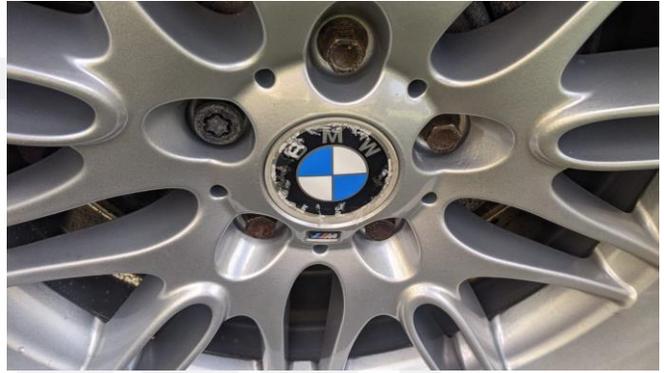
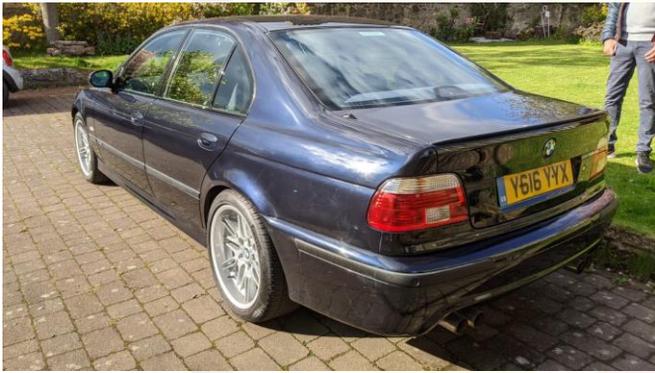
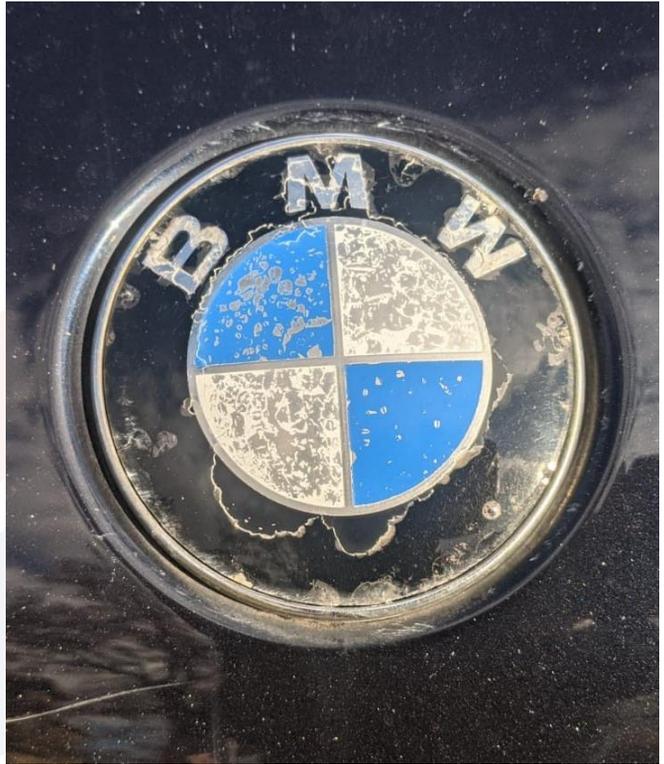
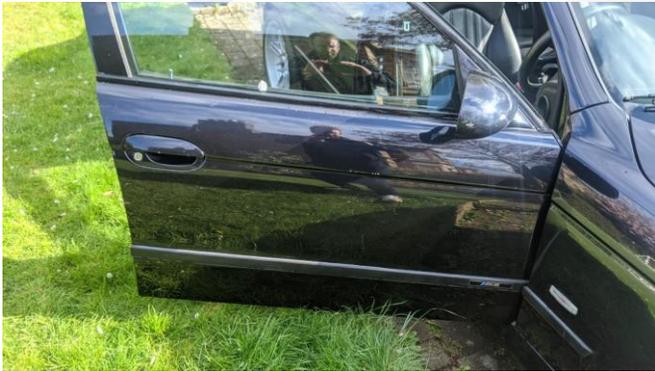
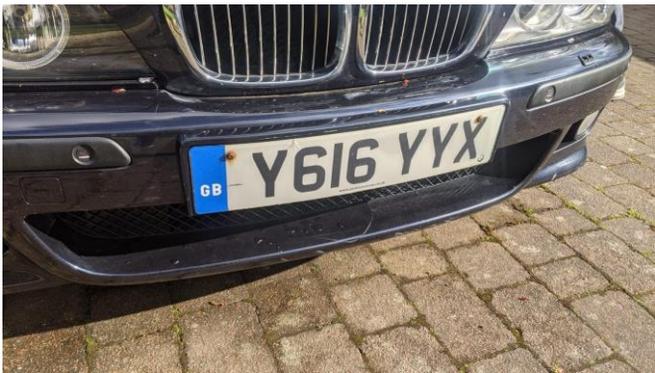
The vehicle is showing signs of its age but can be restored to a new condition. All panels need restoration work, with dings, scratches and tired paint. There is a crack to the front bumper, broken undertray, and chip to the rear spoiler. A full respray of the car is needed. Badges will need to be replaced on the bonnet and the wheels as they are getting old. There is bubbling to the B pillar trim, which is common. Wheels have been restored. There are no signs of rust except for tailgate and inside petrol cap area. We believe the tail pipe can be polished to new.

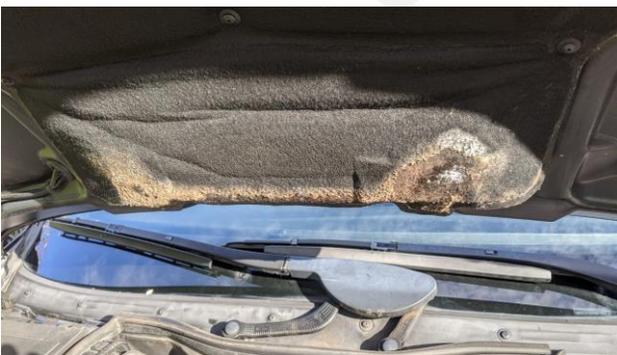
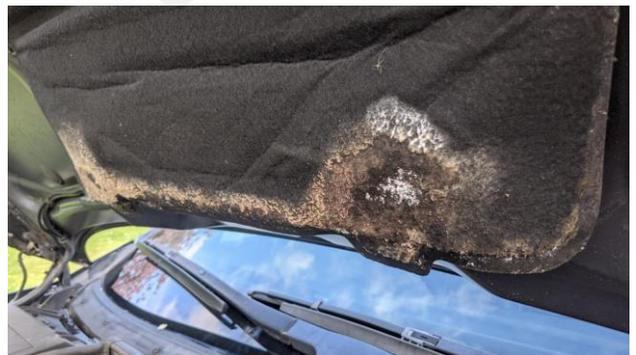
The engine bay looks clean and tidy. The only issue observed was water ingress from either condensation, leaking washer seals or leaking washer jets. This has caused mould to form on the heat proofing, which can be cleaned when the root cause is fixed.

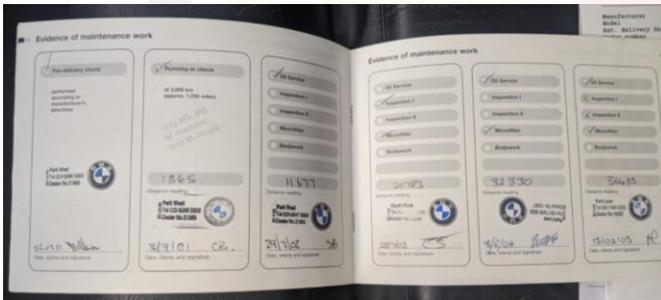
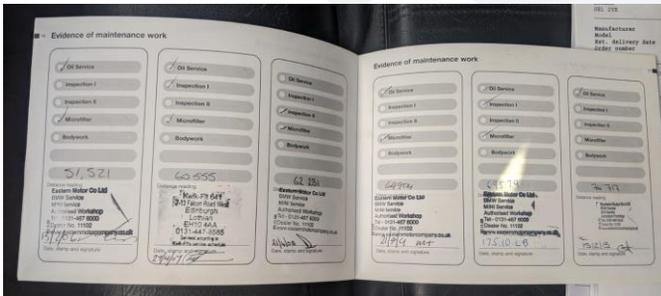
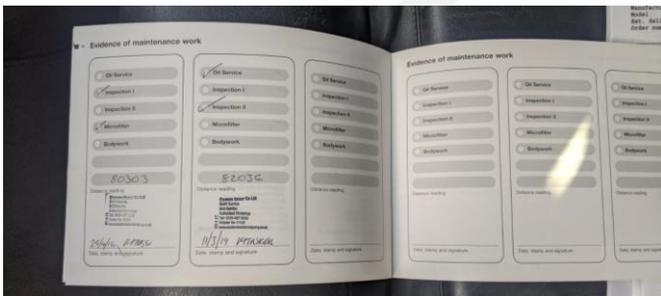
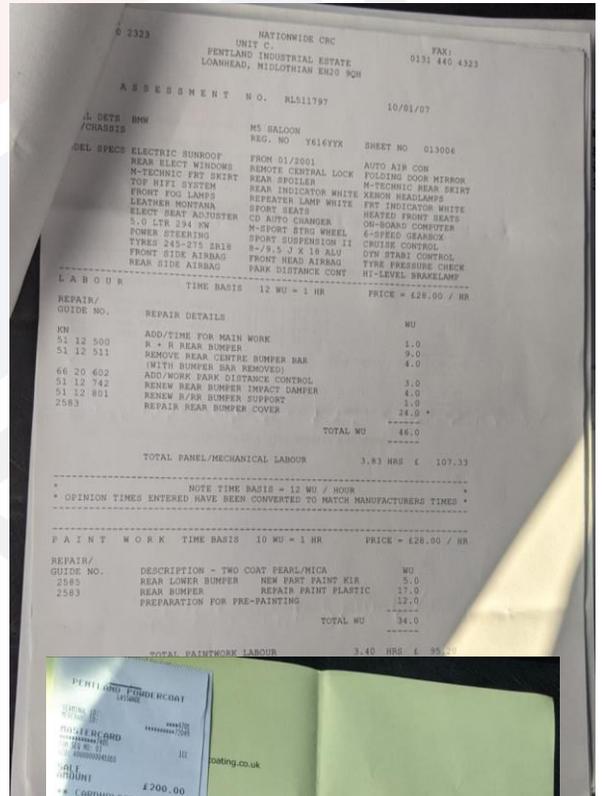
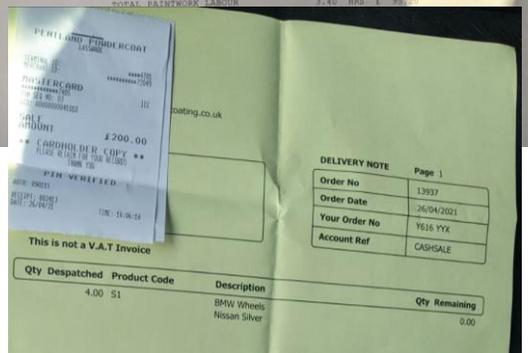
All other paperwork and history forwarded to the buyer shows a great deal of maintenance and upkeep of all service items as would be expected. These include all of the expected invoices for brakes, cooling, clutch, seals, fuel and brake pipes, suspension bushes and auxiliary drive belts as one should expect to replace.

In addition to this, the wheels were restored this year and they are to a good standard. Only the centre caps need replacing.
